MISCELLANEOUS PAPER GL-86-34

EVALUATION OF ASPHALT RUBBER AND ENGINEERING FABRICS AS PAVEMENT INTERLAYERS

R. C. Ahlrich

Geotechnical Laboratory

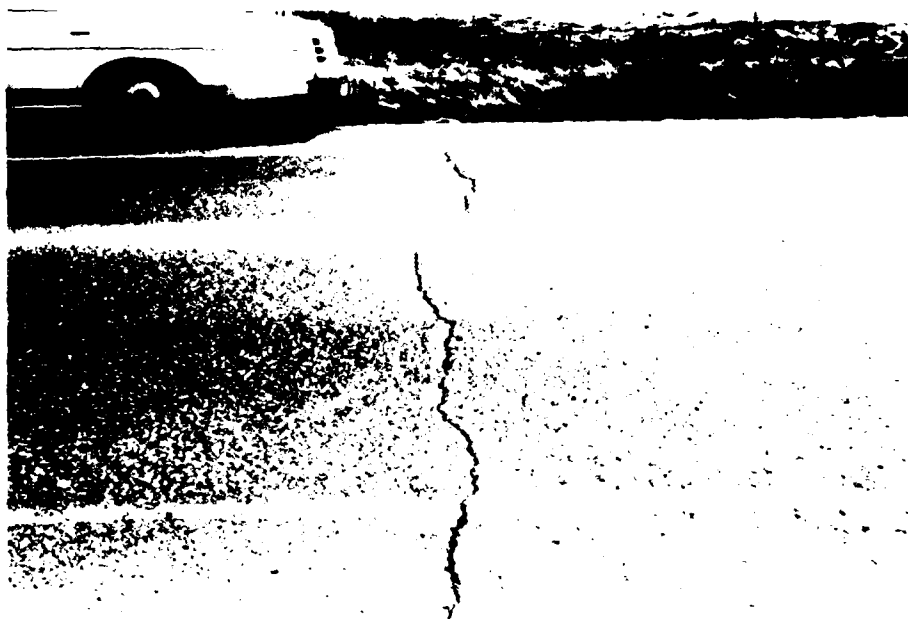
35. The field inspection was conducted in April 1984, 6 years after the installation of the reflective crack treatment. At the time of inspection, the interlayer was functioning very well controlling reflection cracks from the underlying pavement. The cracks in the test section over the PCC pavement were reflecting through approximately every 30 ft (9.14 m) while transverse cracks were appearing every 100 ft (30.48 m) in the AC portion. Typical cracking of this pavement is shown in Figures 20 and 21. According to the Washington State DOT, the asphalt-rubber interlayer has been a success.

Figure 20. Typical transverse crack over original PCC pavement, US 2, Spokane County

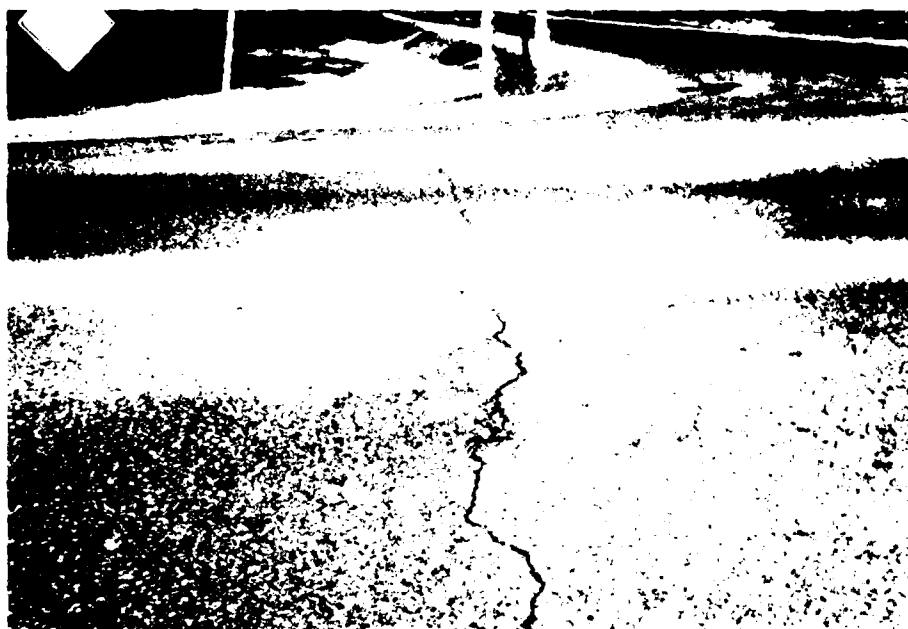
Figure 21. Typical transverse crack over original AC pavement, US 2, Spokane County
